Identifying Potential Reasons for Rail Clip Failure

Noise Reductions through Rail Grinding

Hugh Saurenman, Shawn Duenas

ATS Consulting

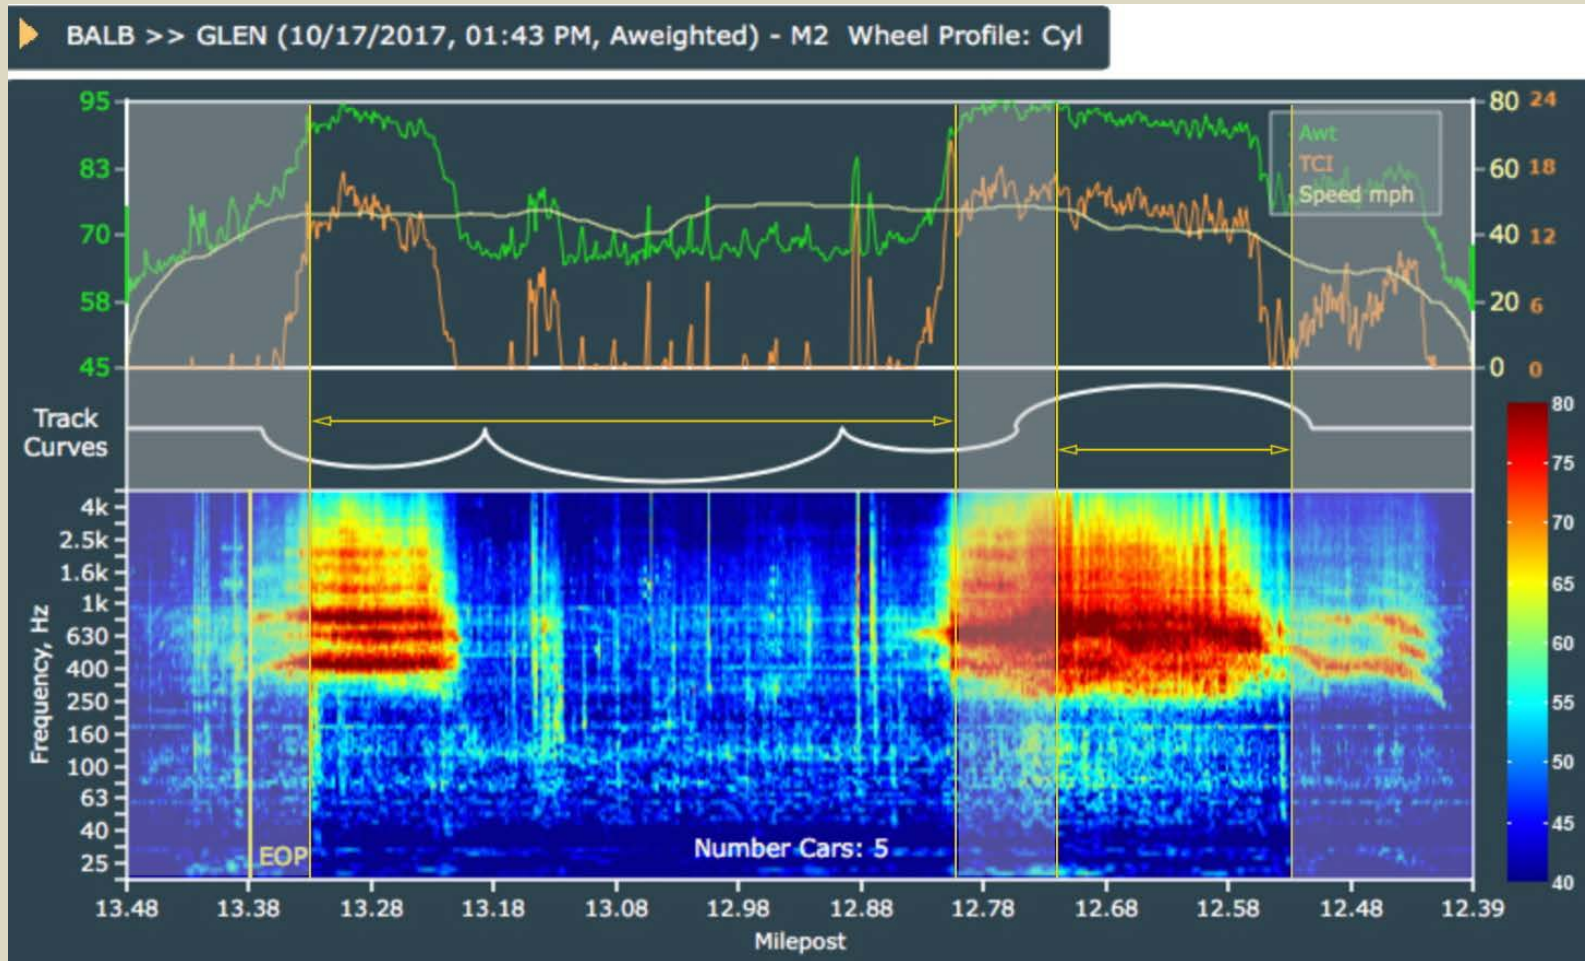
Balboa to Glen Park after grinding

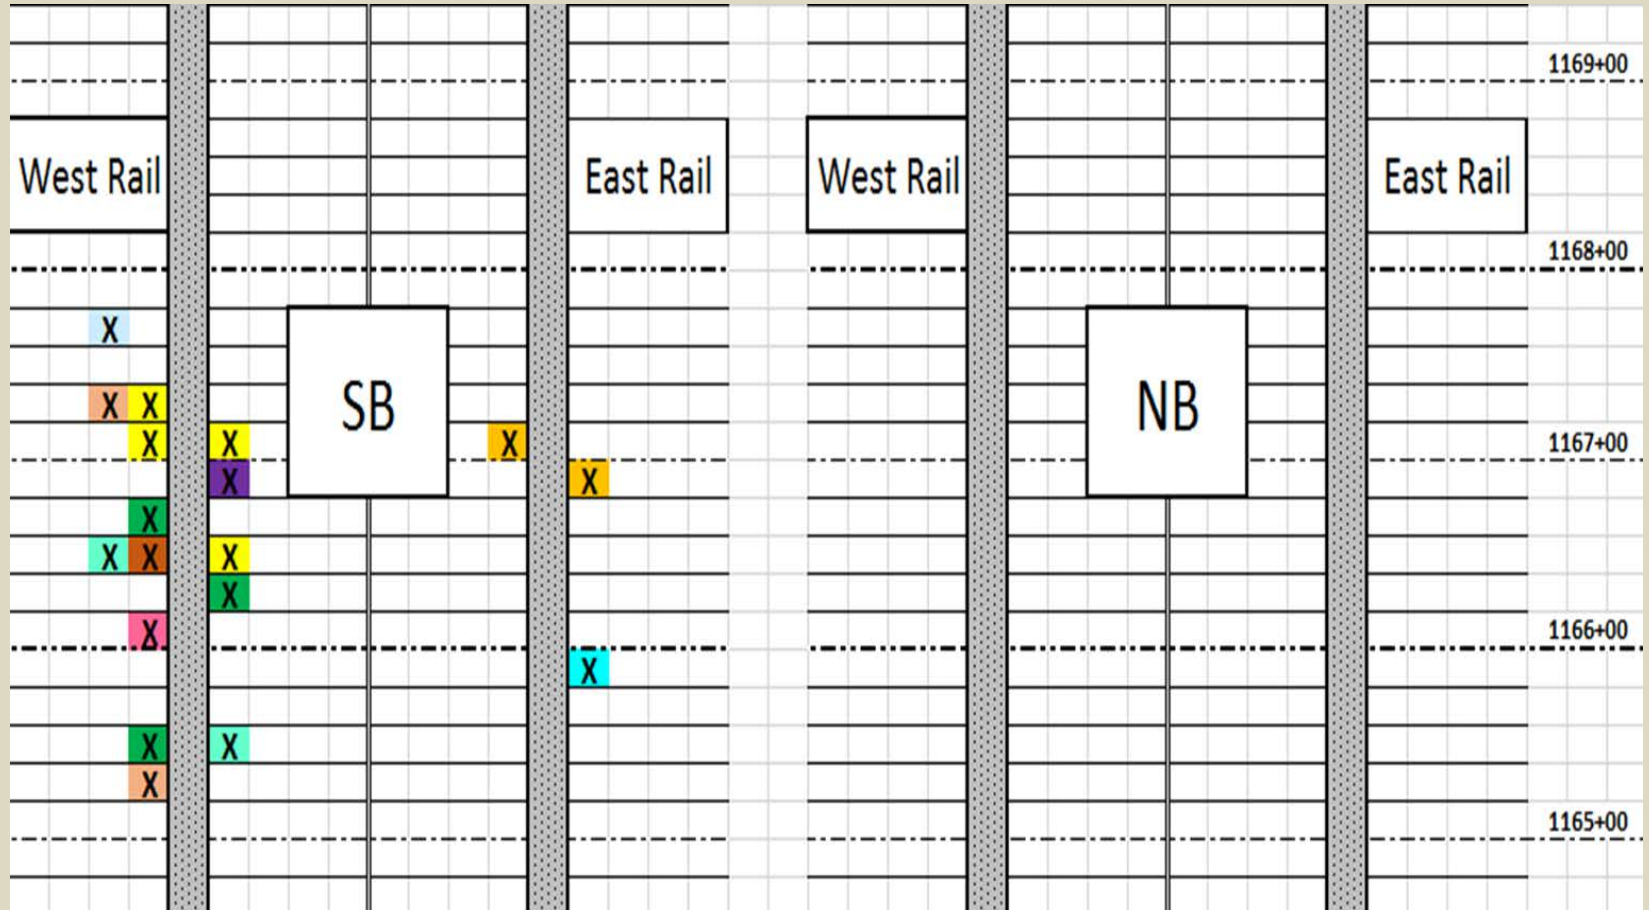
Map of Clip Failures

Clip Failures – As of 4/11/2017 – 1 Year

North Bound Track				South Bound Track			
	East Rail		West Rail		East Rail		West Rail	
	Field Side	Gage Side	Field Side	Gage Side	Field Side	Gage Side	Field Side	Gage Side
GAUGE/FIELD	4	5	5	6	18	22	36	21
EAST/WEST	9		11		40		57	
NORTH/SOUTH	20				97			
TOTAL	132

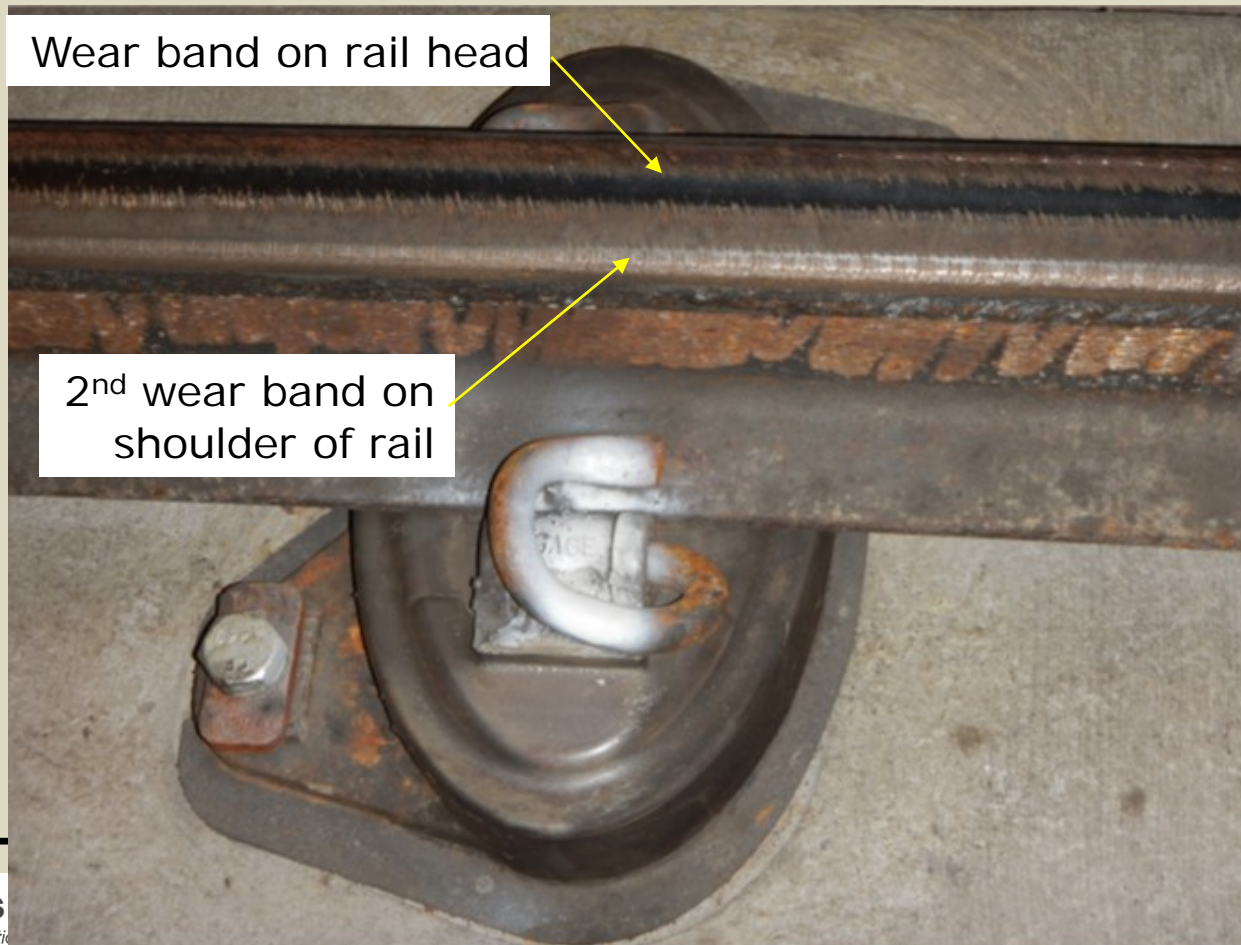
UW Station to Capital Hill Station,
two point contact

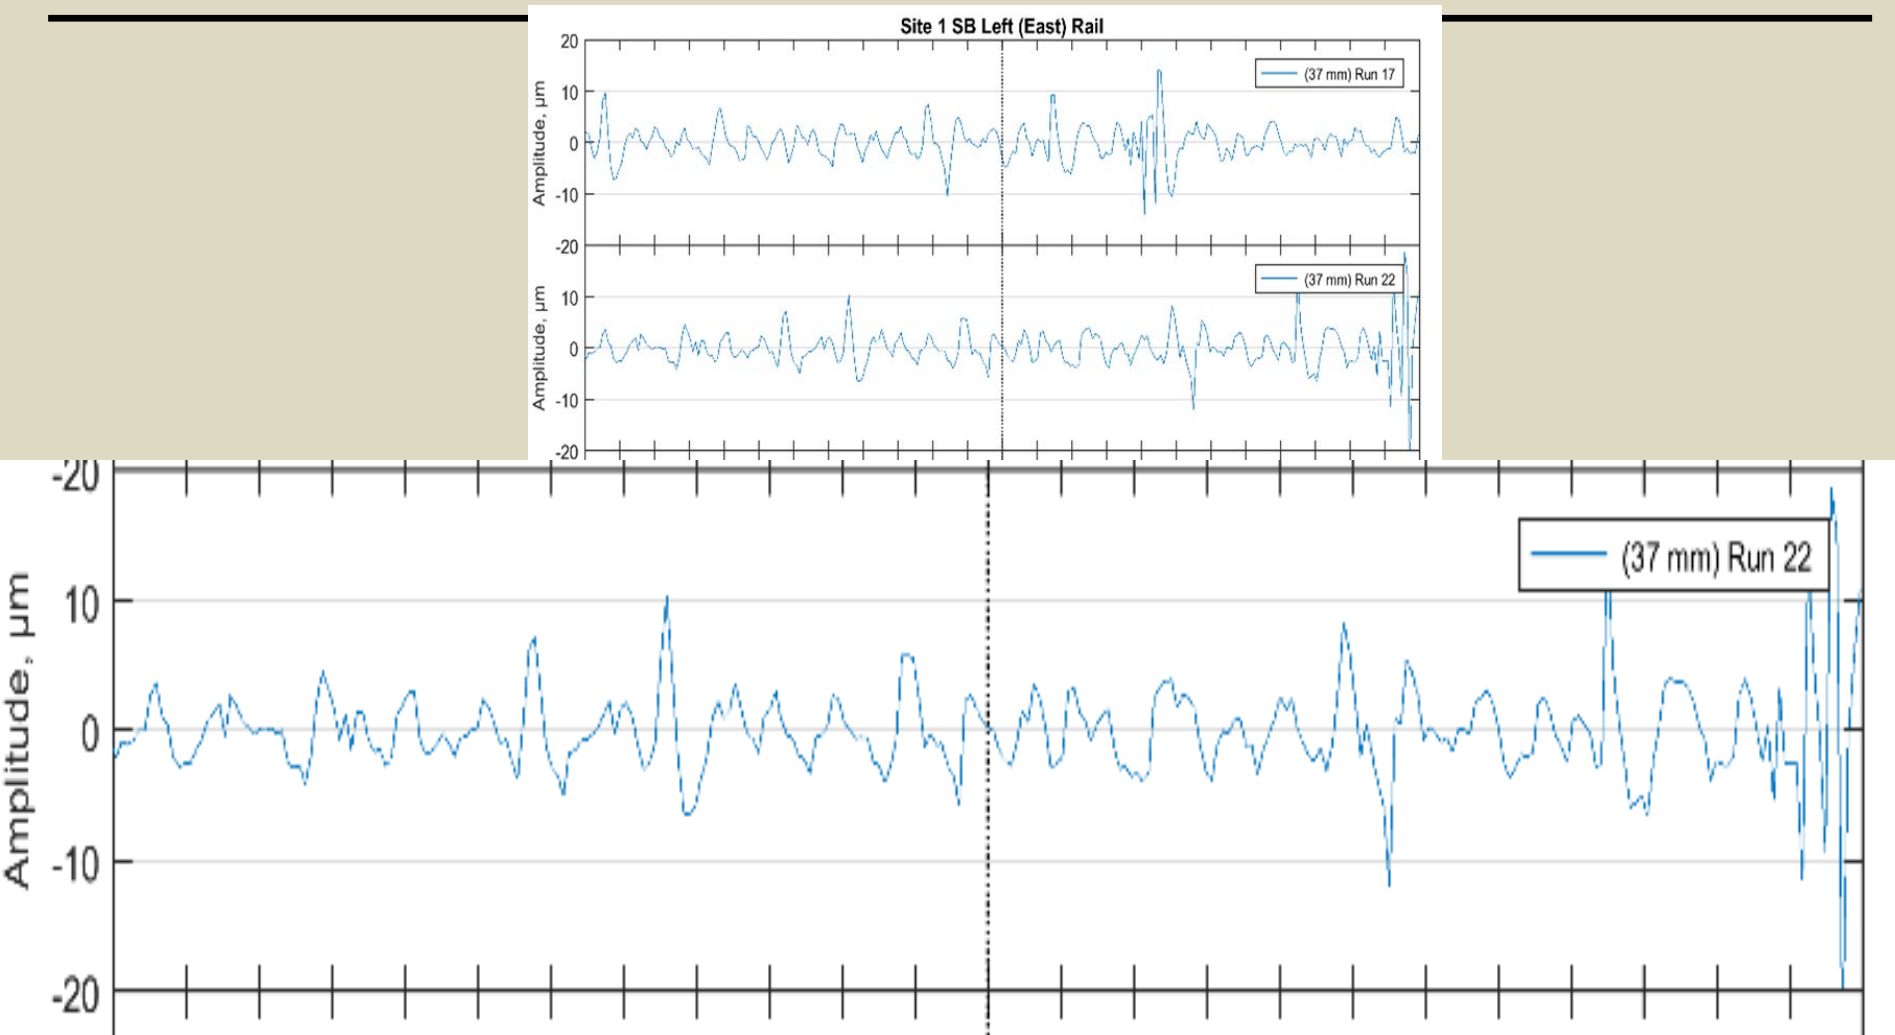
Raw Rail Roughness, UWS-CHS

- Rail grinding left $\sim 1.1''$ wavelength.
- At 55 mph, $1.1''$ wavelength causes vibration at 848 Hz.
- There are short segments where this wavelength disappears.
- Resonance of rail fastener system is 850 Hz.
- Most rail clip failures correlate with locations where the 800 to 900 Hz rail roughness peak is strongest.

- Replace clips with heavier duty clips
 - New specification for rail grinding/polishing
 - Careful oversight of rail grinding
 - Investigation of different grinding wheels
 - Check of rail grinding quality with Corrugation Analysis Trolley (CAT) and onboard noise measurements (CorrTracker)
 - Initial collaborative evaluation program with Rail Grinder, ARM and ATS to verify that new spec can be achieved
-
