# Rail Clip Failure Investigation at Sound Transit

ADC40 SUMMER MEETING 2018

WILSON IHRIG  
ACOUSTICS, NOISE & VIBRATION

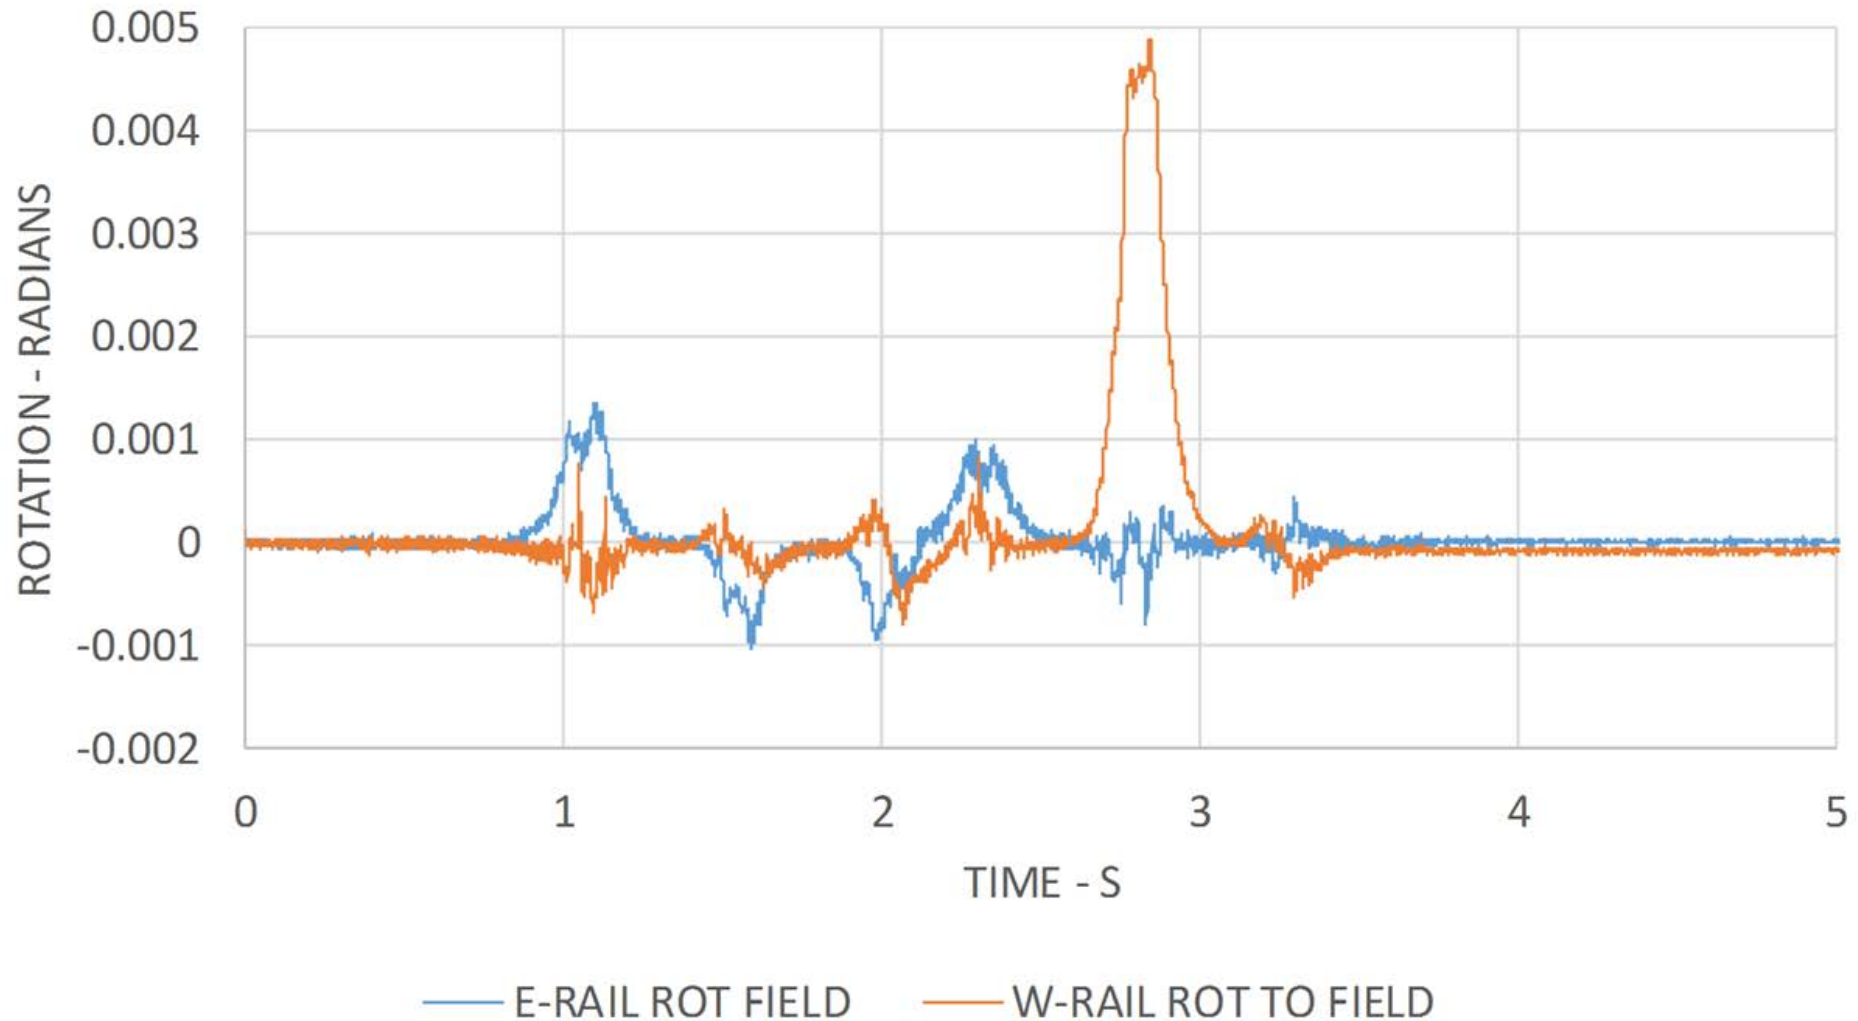
# Southbound Track Rail Rotation

- Center truck produces largest rail rotation and lateral displacement
- No evidence of clip toe load being overcome
- No clear evidence of fatigue due to relative deflection of rail and fastener
- Acceleration spectrum contains strong peaks above 800Hz
- Laboratory tests indicate system resonance at about 800 to 900Hz
- Amplification of rail vibration acceleration at nominally 800 to 900Hz
