NCHRP 25-25 Task 72

Construction Vibration and Historic Buildings

A Case Study

Presented to
TRB ADC40 Committee Summer Meeting
Santa Fe, NM - July 2013

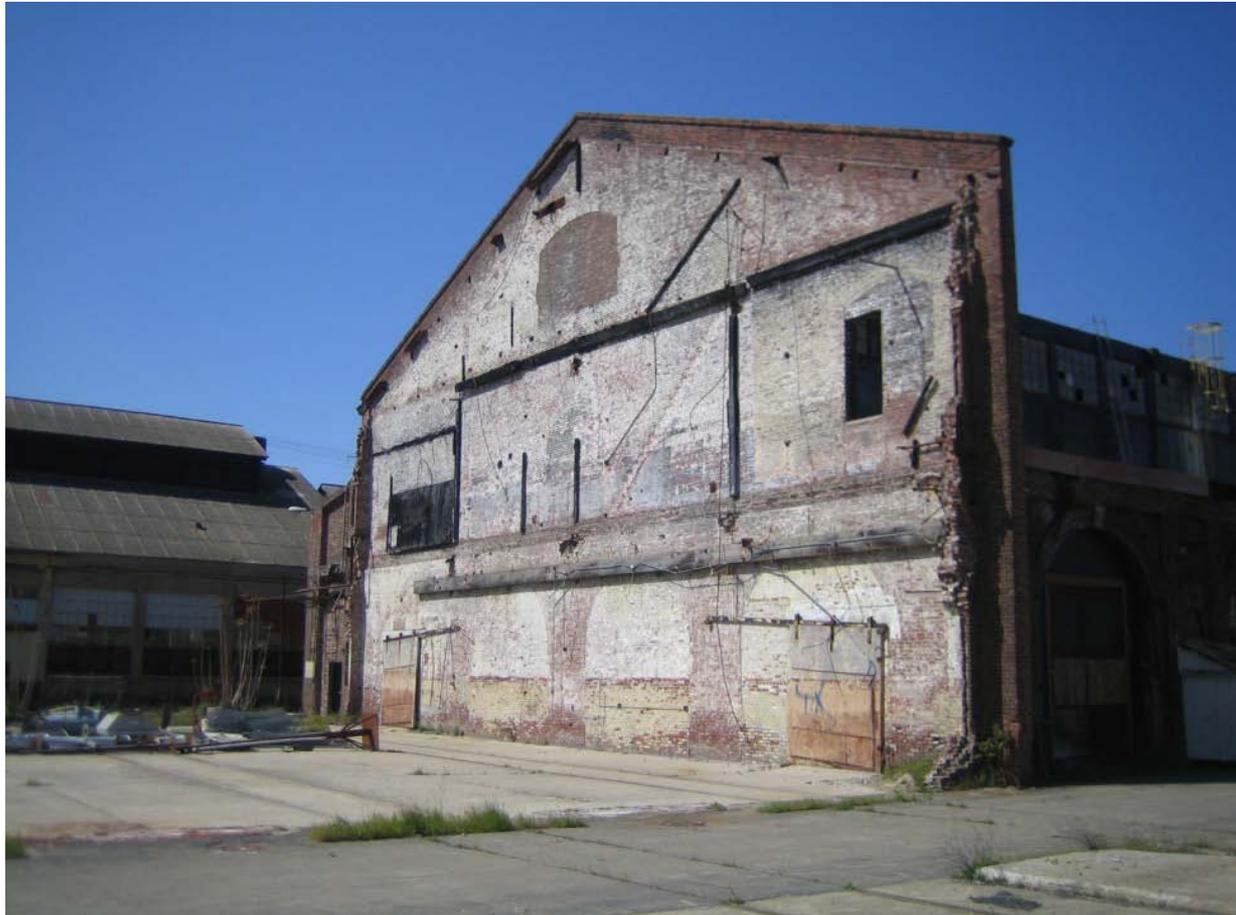
Car Shop within the Central Shops Historic District

- Findings of SGH building investigation
 - State of masonry walls varies considerably
 - Localized areas of large cracks due to foundation settlement
 - Some exterior masonry repointed and in relatively good condition
 - Where no repointing, exposed lime mortar in bad shape with little or no adhesion to brick
 - 1850 building worse than 1880 vintage buildings
 - Masonry walls either 3 or 4 wythes
 - Brick size: 2 ¼ " high x 4" wide x 7⅞" long
 - ⅜" lime mortar joint

- SGH Concluded:
 - Remedial work required for Car Shop structure to meet local codes and become serviceable to the public
 - If peak vertical vibrations are below 0.32 inches/sec at Car Shop then there should be no risk of masonry wall becoming unstable
 - Other building walls in Central Shops complex capable of withstanding this level of vibration in their current condition

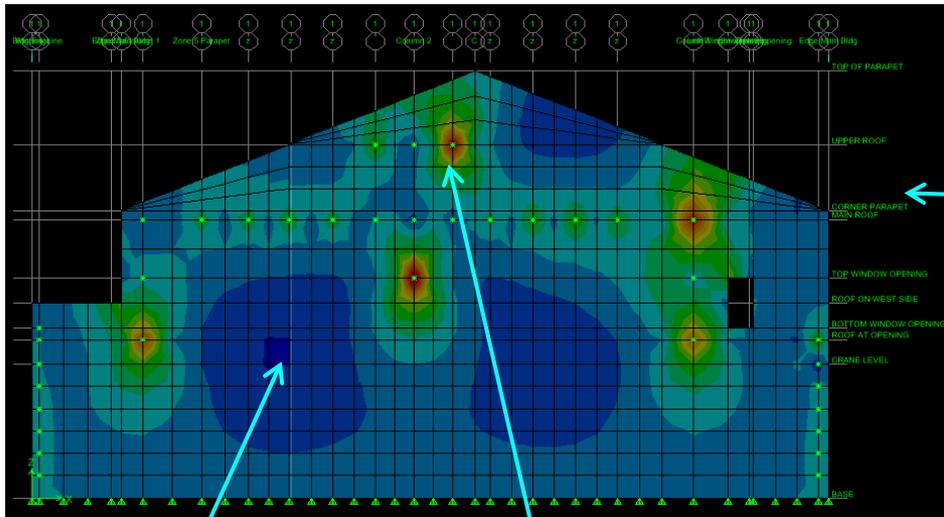
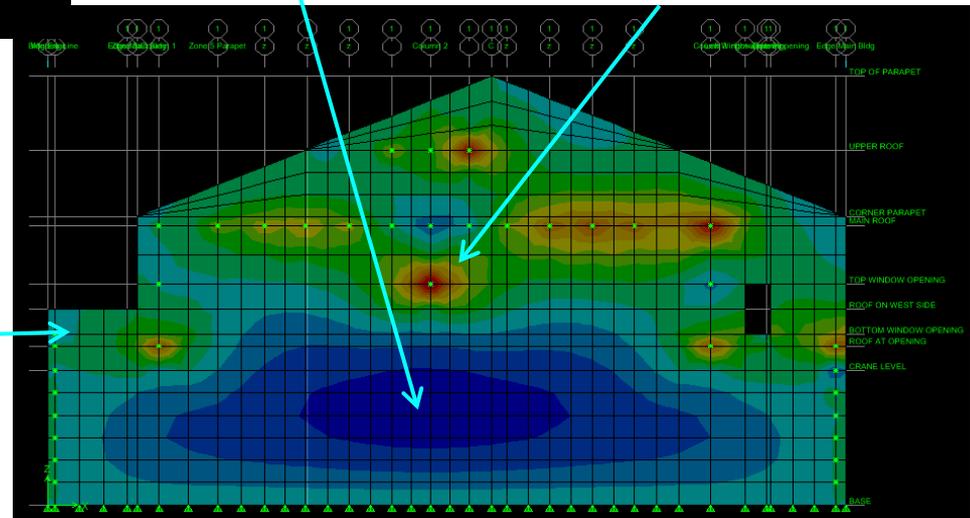
“Static” Wind Load FEA Model Response

- Structural Evaluation Results:
 - Out-of-plane forces due to lateral train vibrations are smaller than historic based wind load demands at the site
 - Existing wall has been capable of withstanding wind loads over its 130 year existence
 - Existing wall is stable for the anticipated train induced ground vibrations predicted for the site
