# High-Frequency Squeal Noise in Large Radius Curves

Keith Yoerg  
Associate, ATS Consulting

July 2017

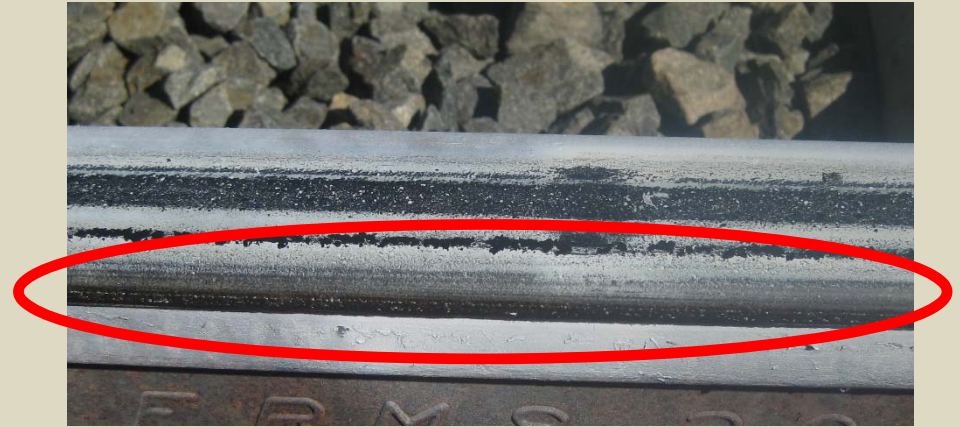
- Painting the rail reveals points of contact between the wheel and rail
- Consistent, clean contact band on the top of rail is ideal
- FTA states that turns with radii greater than 1,000 ft “avoids squeal”
  - This curve is 1,400 ft

Outside (high) rail – evidence of flanging

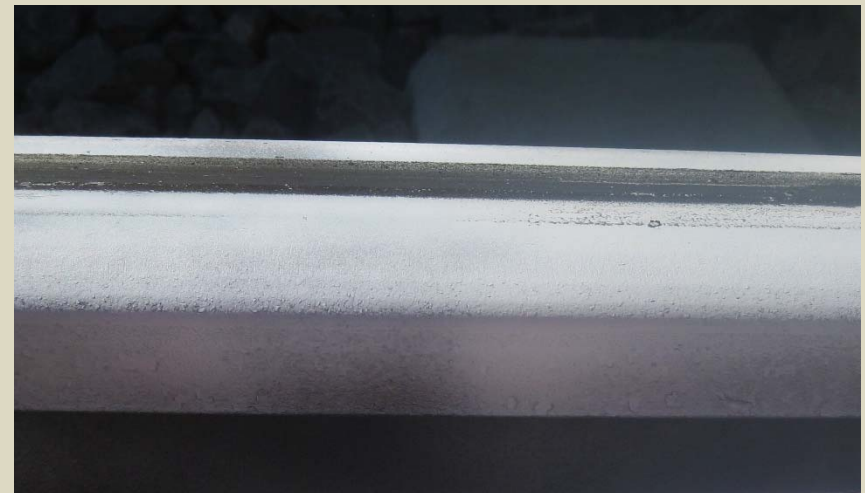
Inside (low) rail – consistent contact band

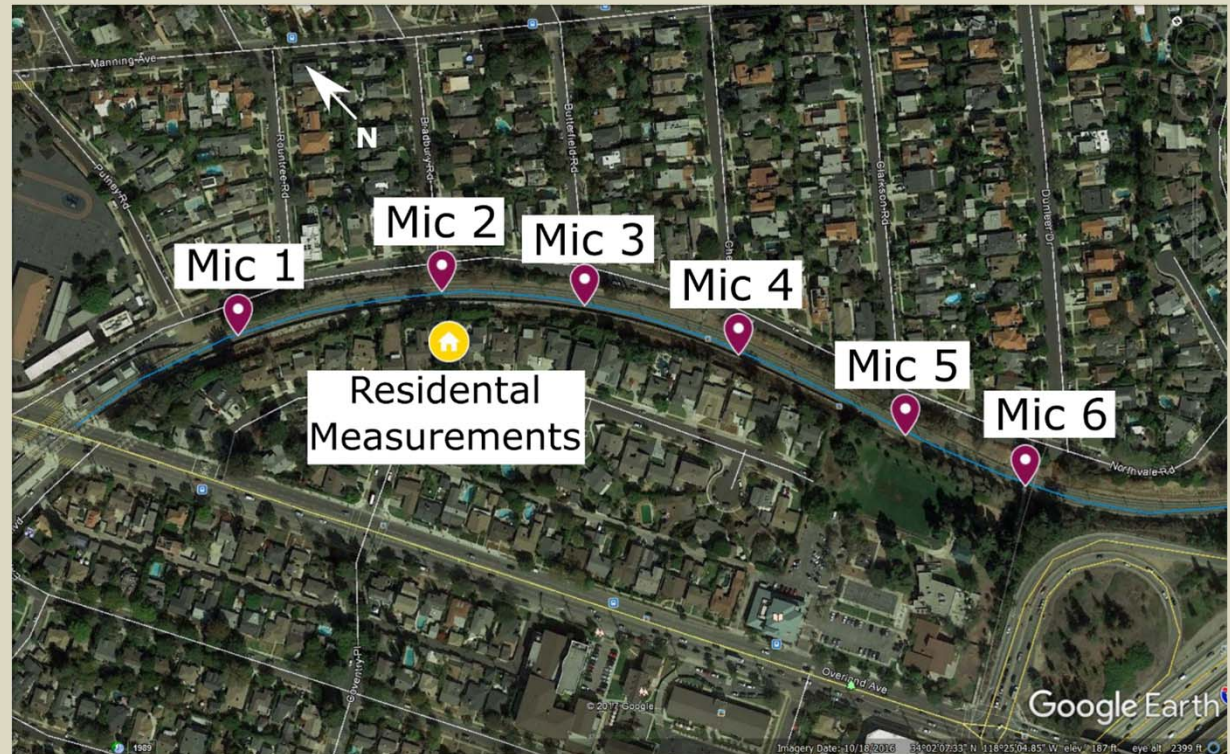
# Noise at Northvale Curve

- Moderate impact threshold:  $L_{dn} = 56$  dBA
- Measured, train-only level:  $L_{dn} = 50$  dBA
- Residents complain about the high-frequency noise from the trains
- Measurements conducted between May 2016 and April 2017
