Identifying Potential Reasons for Rail Clip Failure

Noise Reductions through Rail Grinding

Hugh Saurenman, Shawn Duenas

ATS Consulting

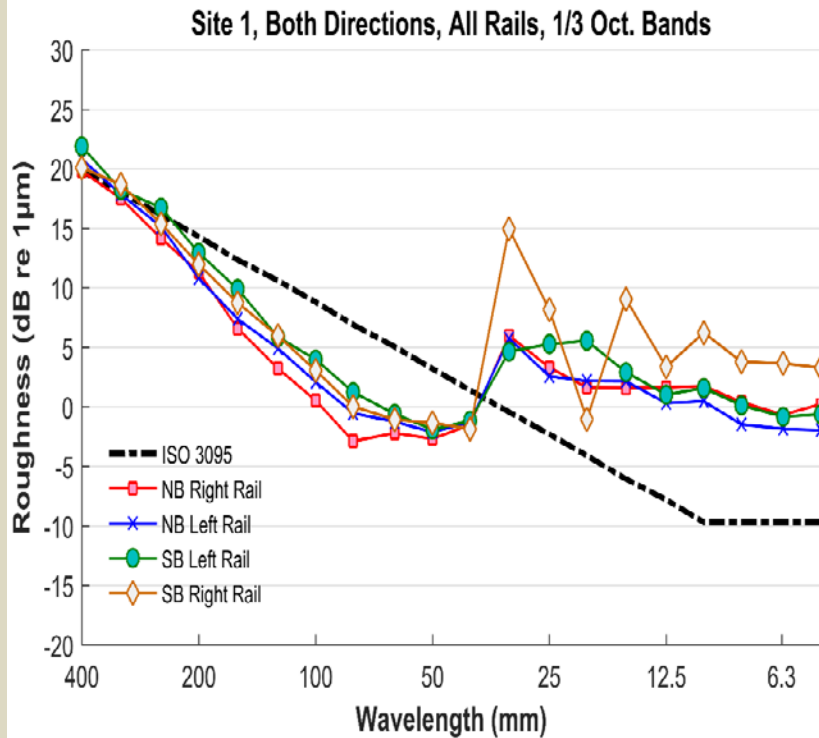
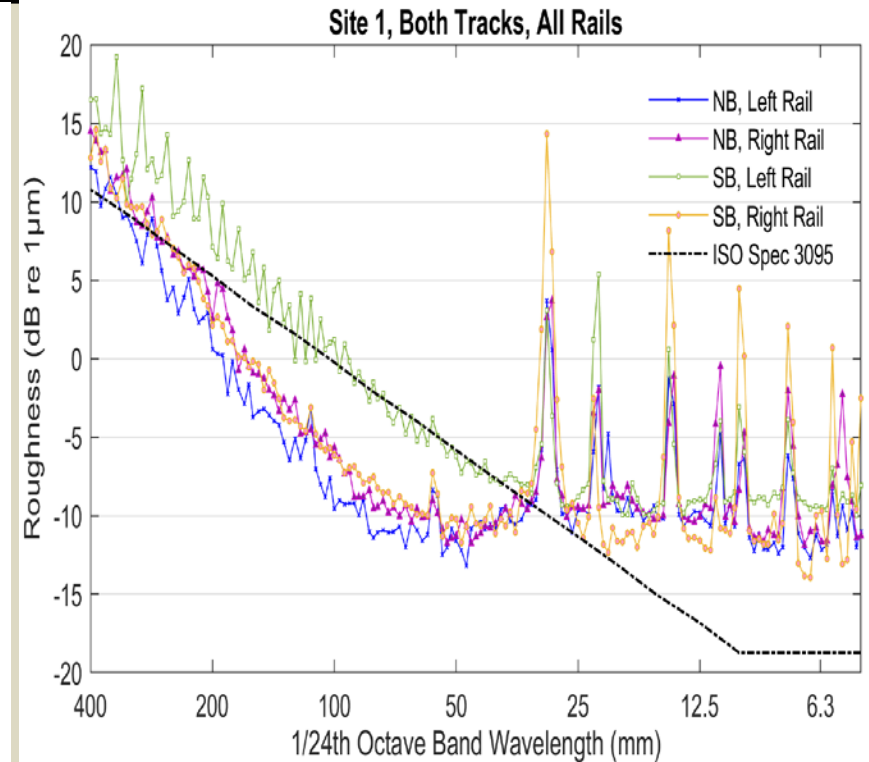
Rail Rough Spectrums

- Rail grinding left $\sim 1.1''$ wavelength.
- At 55 mph, $1.1''$ wavelength causes vibration at 848 Hz.
- There are short segments where this wavelength disappears.
- Resonance of rail fastener system is 850 Hz.
- Most rail clip failures correlate with locations where the 800 to 900 Hz rail roughness peak is strongest.

- Replace clips with heavier duty clips
 - New specification for rail grinding/polishing
 - Careful oversight of rail grinding
 - Investigation of different grinding wheels
 - Check of rail grinding quality with Corrugation Analysis Trolley (CAT) and onboard noise measurements (CorrTracker)
 - Initial collaborative evaluation program with Rail Grinder, ARM and ATS to verify that new spec can be achieved
-
