NCHRP 25-25 Task 72

Construction Vibration and Historic Buildings

A Case Study

Presented to
TRB ADC40 Committee Summer Meeting
Santa Fe, NM - July 2013

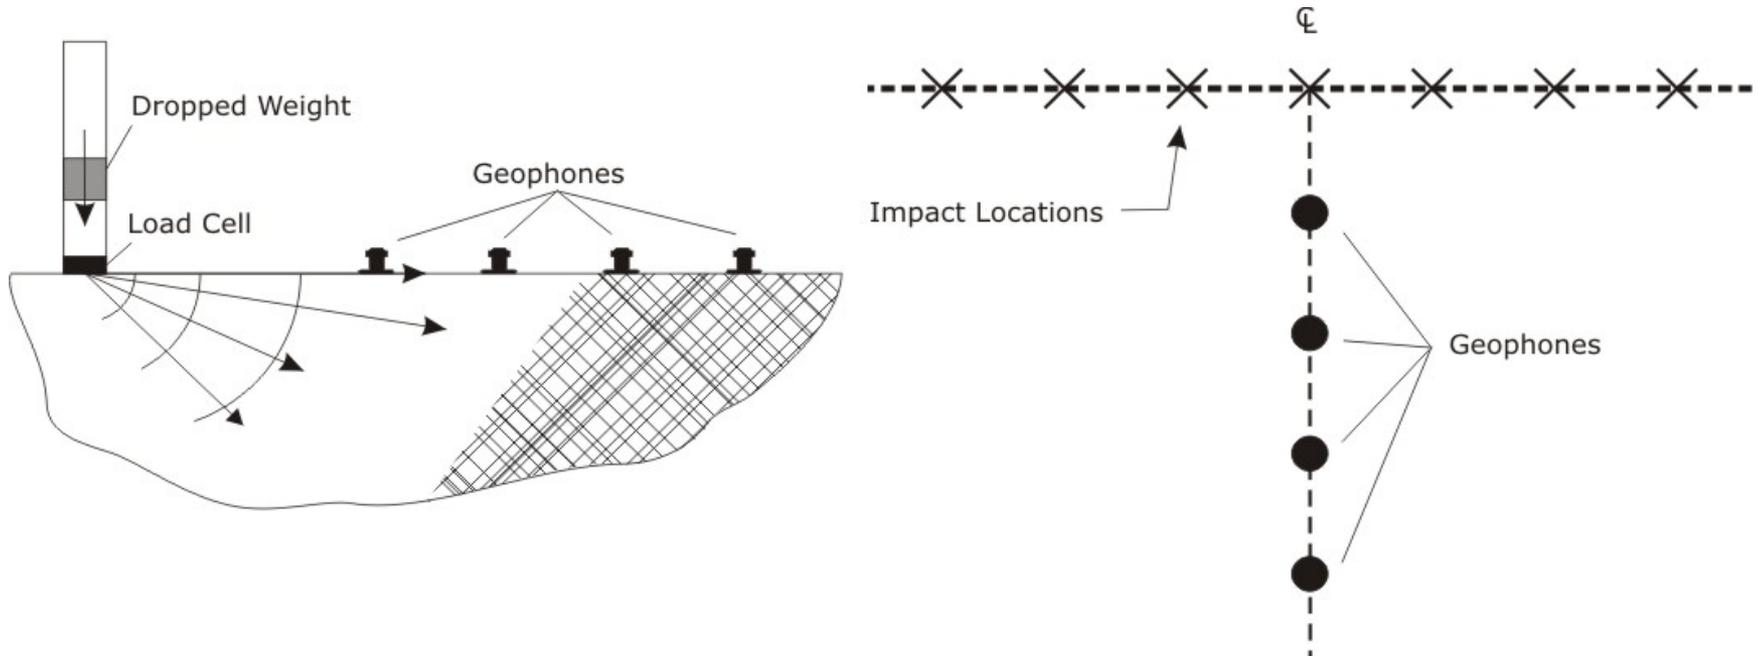
Vibration Propagation Measurements at Site

- Local soil conditions
 - Site is adjacent to Sacramento River
 - River used to flood regularly until levees were built
 - Surface layers consist of two fluvial-deposited sediments
 - Sedimentary layer of rock is at a depth of 3,000 feet
- 2009 Vibration predictions
 - Site LSRs indicate soil conducive to high vibration
 - LSR includes building foundation
 - Distance to the most sensitive building is 32 feet
 - Train speed of 30 mph
 - Measured freight FDL appears to include some wheel flats
 - Peak vertical vibration of 0.32 in/sec

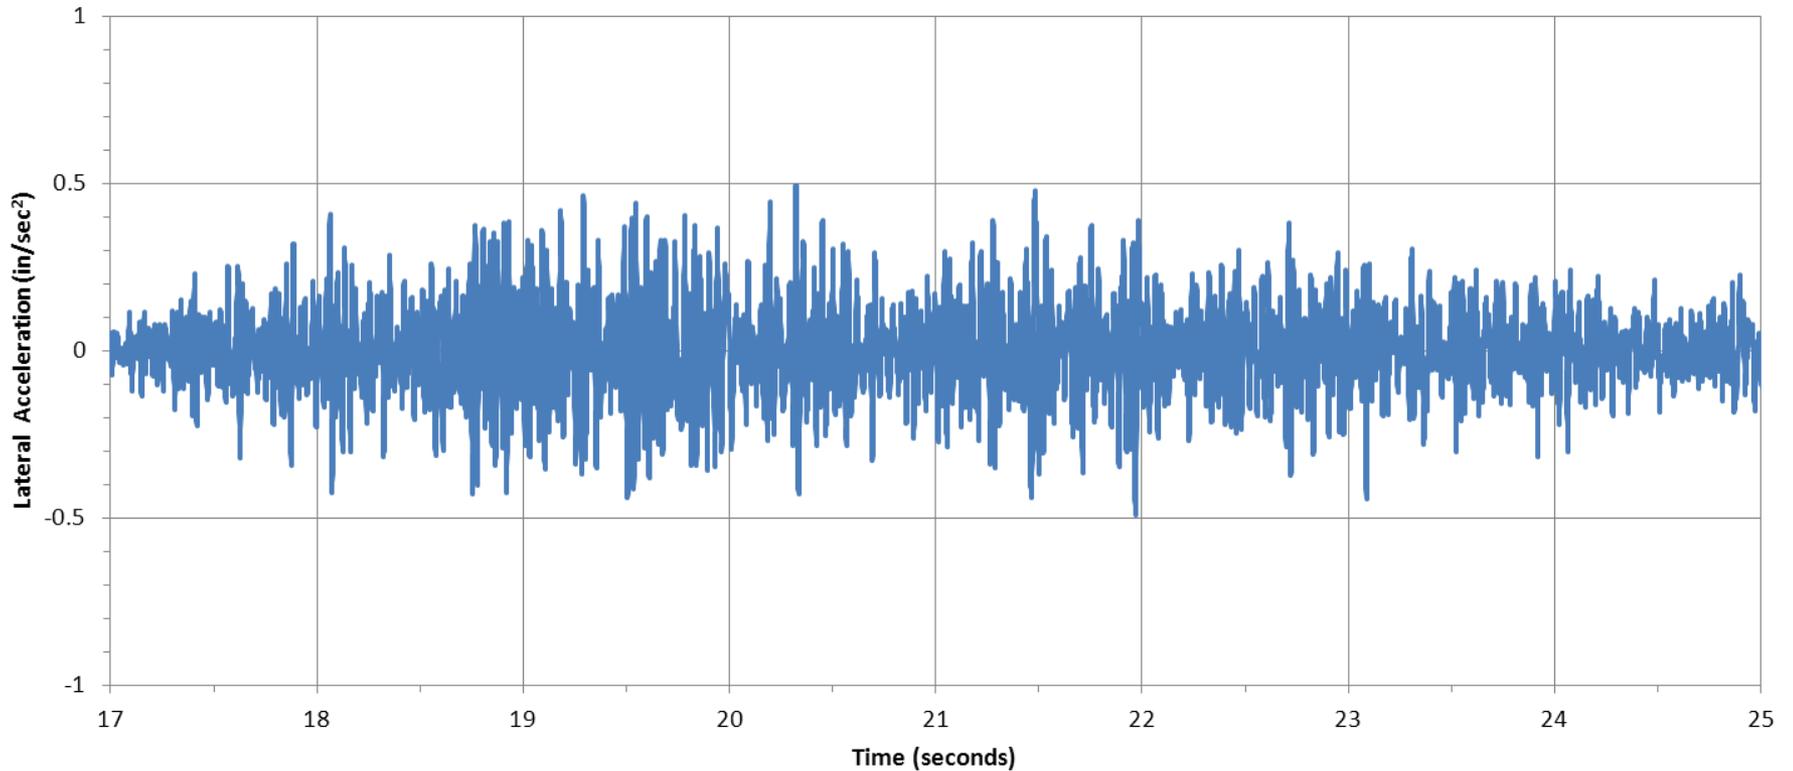
Typical (Un-scaled) Freight Train Lateral Acceleration Waveform

- Structural Evaluation Steps:
 - Create FEA model with elastic shell elements representing unreinforced masonry bearing wall in CSI ETABS
 - Condition 1: Freight train loads modeled as scaled, lateral ground acceleration time history
 - Condition 2: Typical maximum static wind loads
 - Run FEA model to analyze the building
 - Compare output from Conditions 1 & 2 and determine which loading is more severe on the wall
 - Check demands versus existing wall capacity for the more severe condition
